ŞANLIURFA BRT ROAD SAFETY AND ACCESSIBILITY PROJECT

Safe and Accessible Urban Transport

In April 2015, at the request of the Şanlıurfa Metropolitan Municipality, in Southeastern Turkey, EMBARQ Turkey conducted a road safety and accessibility inspection of the City's BRT (Bus Rapid Transit) corridor.

This present report was prepared to present recommendations for deficiencies and problems identified in the inspection of the Şanlıurfa BRT corridor. The recommendations provided in this report are the results of field work evaluations and office work regarding road safety and accessibility.

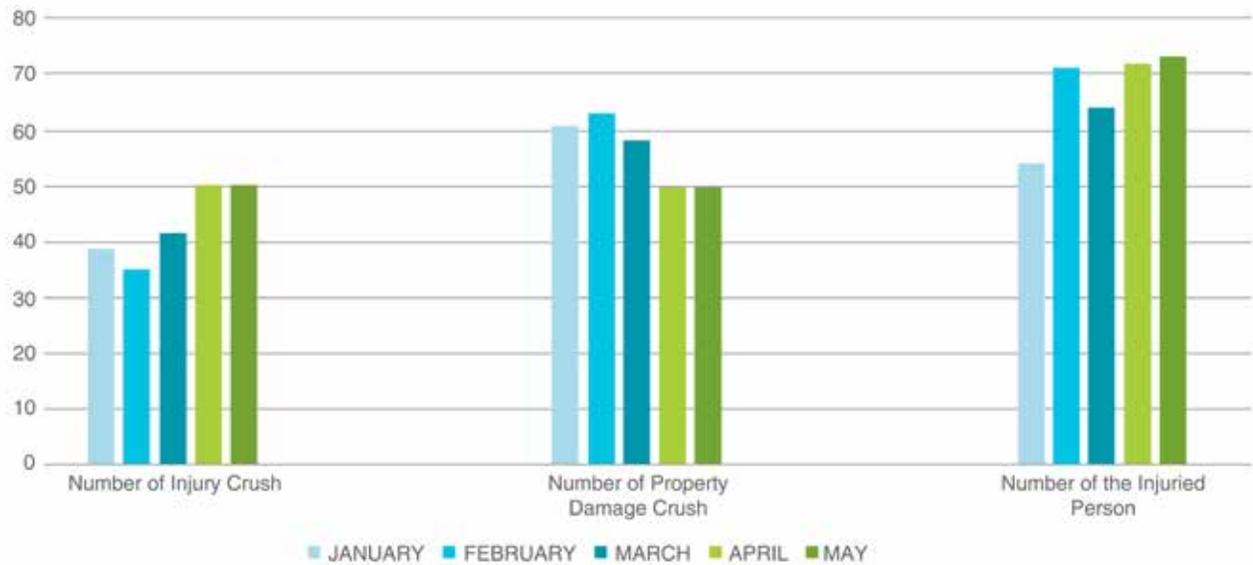
- In January 2015, 40% of traffic collisions involved injuries and 60% resulted in material damage.

- In February, injury-related collisions decreased by 35% while collisions with property damage increased.
- Injury-related collisions increased in March, April, and May.
- In 2015, 69% of the traffic collisions occurred during the daytime.
- "AUTOMOBILE" motor vehicle collisions are ranked first with 218 incidents while "MOTORCYCLE" is second with 79 incidents in 2015.

Figure 2 Distribution of injuries and property damage in traffic crashes occurred in the first 5 months of 2015 (EMBARQ Turkey, 2015)

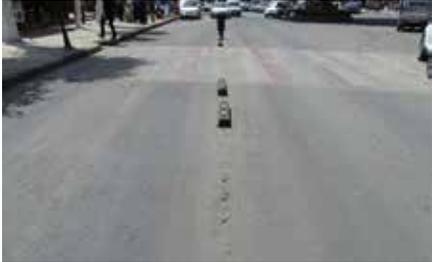
<p>Maintenance along the BRT corridor</p>	<ul style="list-style-type: none"> • Markings should be regularly maintained and made of a durable material 	<p>Figure 5 Delimitation between the BRT lane and mixed traffic lanes (EMBARQ Turkey, 2015)</p>

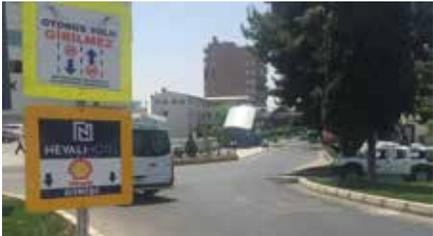
<p>Trespassing of private vehicles on BRT lane</p>	<ul style="list-style-type: none"> • Enforcement • Pre-warning signs should be placed 	<p>Figure 6 Entrance of Abide intersection (EMBARQ Turkey, 2015)</p>

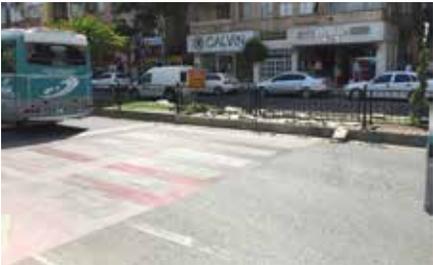
<p>Misleading traffic signs from previous infrastructure</p>	<ul style="list-style-type: none"> • Old markings should be removed 	<p>Figure 8 Misleading traffic signs from previous infrastructure (EMBARQ Turkey, 2015)</p>

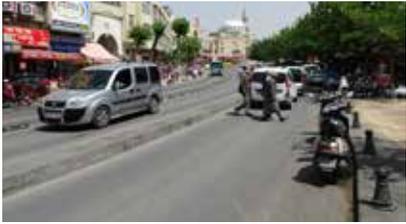
<p>Lack of parking lots for motorcycles and bicycles which leads to parking on the BRT and bus lanes</p>	<ul style="list-style-type: none"> • Assigning parking lot to motorcycles • High price policy to reduce the demand 	<p>Figure 10 Motorcycles parked on bus lanes (EMBARQ Turkey, 2015)</p>

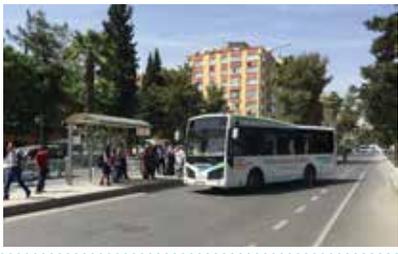
<p>Lack of bus driver training on road safety and other traffic issues</p>	<ul style="list-style-type: none"> • Road safety and safe drive trainings should be given to bus drivers 	<p>Figure 12 Access to BRT stations (EMBARQ Turkey, 2015)</p>

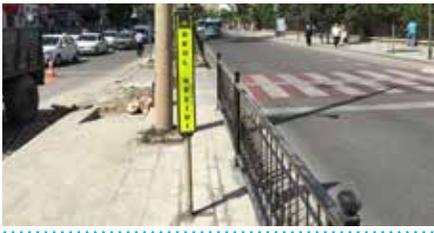
<p>Pedestrians jumping over guardrails</p>	<ul style="list-style-type: none"> • The guardrails should be established with higher ones 	<p>Figure 13 The guardrails along the Atatürk Street (EMBARQ Turkey, 2015)</p>

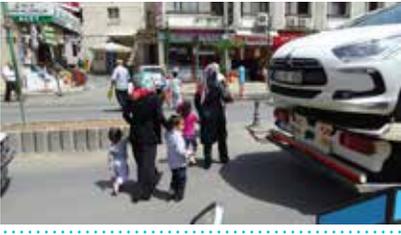
<p>Gaps along the guardrails</p>	<ul style="list-style-type: none"> • Guardrails should be established 	<p>Figure 14 Vulnerable road users - Balıklı Göl Street (EMBARQ Turkey, 2015)</p>

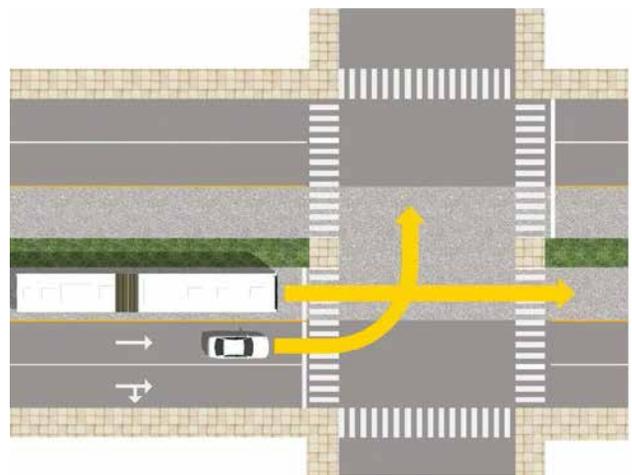
Figure 17 Left turns across the bus lanes (EMBARQ, 2014)

Each left turn added to an intersection can cause a 30%-40% greater risk for incidents including pedestrian-vehicle conflict. Therefore, we suggest to only allowing left turns at locations that comply with the criteria below:

- High volume of left turn traffic is expected or traffic cannot be directed to adjacent streets.
- Areas with long blocks such as industrial areas or large campus areas.

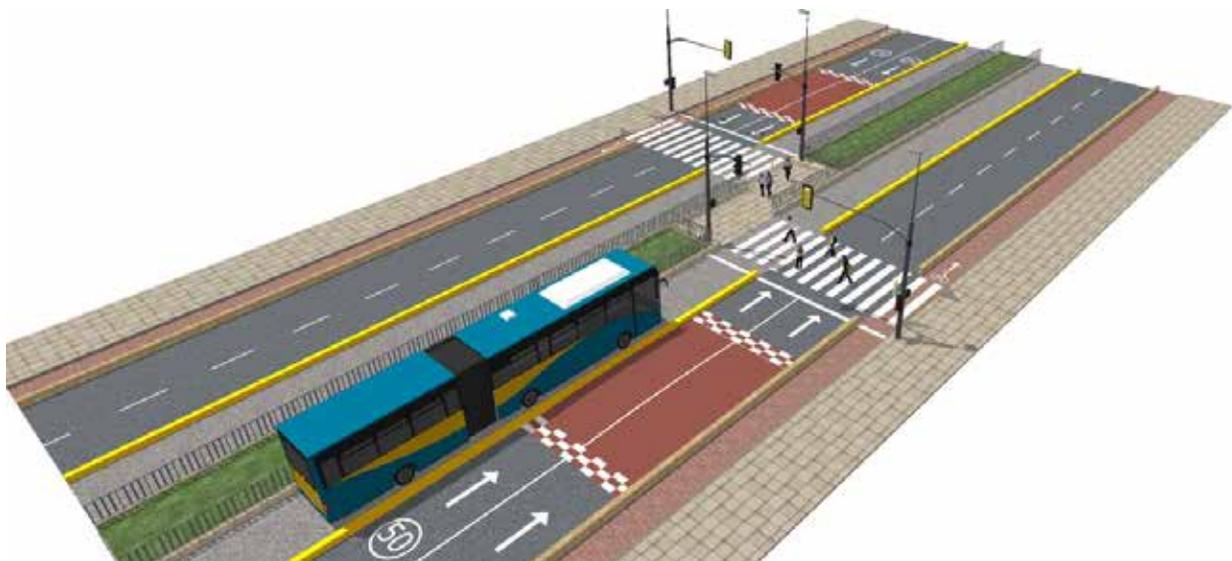
In dense city centers of developing countries, pedestrians tend to cross and/or loiter in bus lanes. Moreover, pedestrians tend to consider bus lanes as safer than traffic lanes due to lower traffic volumes.

In urban environments, buses operate at relatively higher speeds and give pedestrians the least opportunity to cross over. The operating speed of buses and BRT systems is actually a performance indicator. However, increasing speed limits can cause greater risk for pedestrians.

Figure 16 Center BRT lanes with mid-block crossing on a urban arterial (EMBARQ, 2012)

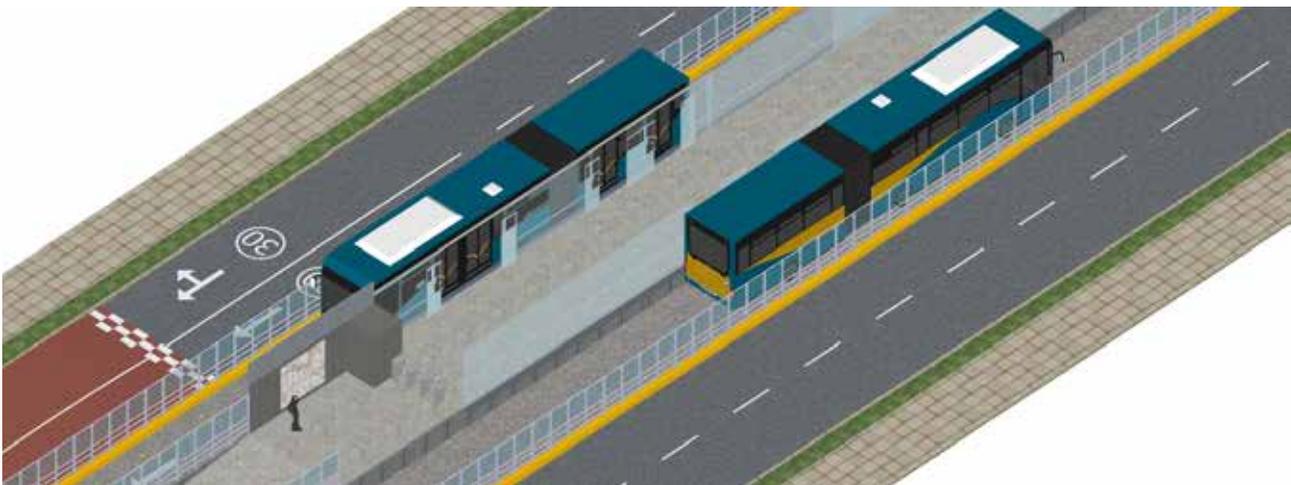
Figure 18 Center BRT lanes with mid-block crossing on a urban arterial (EMBARQ, 2012)
